## Assessment of the Phase 1 of the Asian Clam Treatment at Sand Harbor State Park June - November 2017

# Report to the Nevada Division of State Lands and the Tahoe Regional Planning Agency

Brant Allen, Katie Senft, and Brandon Berry UC Davis Tahoe Environmental Research Center

January 2018

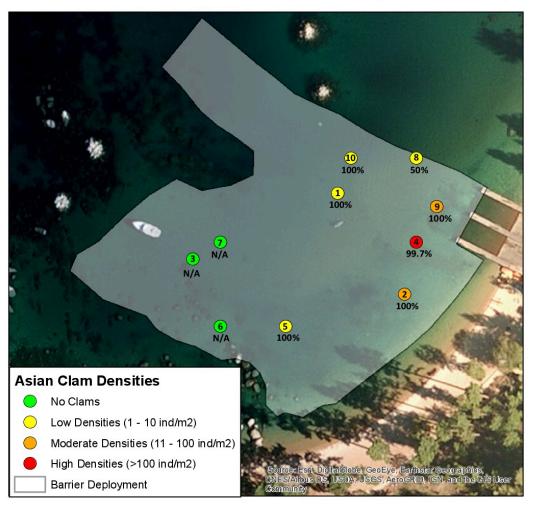
Clam surveys following the Phase 1 treatment indicated a high degree of success in eliminating live clams under the barriers. Seven of the ten 1m<sup>2</sup> excavations recovered clams accounting for 393 clams. Of these 390 were found to be dead (99.2% mortality).

Two of the three clams found alive were recovered from a plot at the edge of the barrier deployment located in front of the boat launch facility (plot 8, figure 3). As described earlier, two barriers in this area were disturbed, allowing oxygenated water to reach the substrate for a brief period of time. Additionally, it is expected that edge effects will be observed where barriers end and uncovered substrate exists. It is possible for clams to move back and forth short distances from the treated and untreated area. The edge also represents the greatest opportunity for water exchange.

Figure 2: Location map of post-treatment 1m² collections for density and percent mortality

It is recommended that the area immediately in front of the boat launch remain covered during Phase 2 of the treatment, and that additional weight be used in order to prevent lifting of the barrier due to propeller wash. The Phase 1 clam mortality assessment found a few live clams persisting in this area. An additional benefit would be providing continuity along the edge of the two treatments, preventing small gaps of untreated substrate.

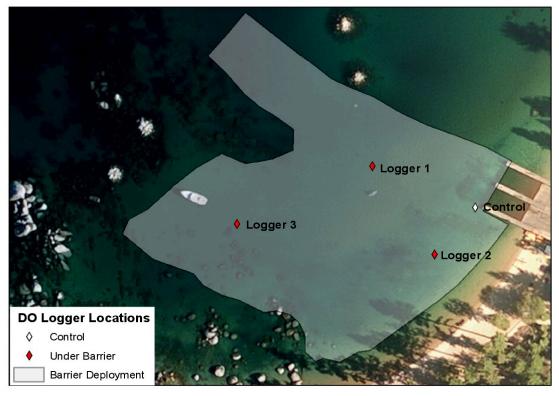
The Phase 1 treatment area was surveyed by TERC researchers on a monthly basis when other work in the area was being conducted. Any minor adjustments to the barriers in order to ensure their integrity with the substrate were done. Observations of large-scale disturbances were reported to the TRPA. Only one occurrence of a major disturbance to the barriers was identified. Two barriers had become detached from the

bottom allowing lake water to reach the substrate. This occurred directly off the boat launch and may have been due to propeller wash as recreational boaters were accessing the ramp.

Figure 3: Map of dissolved oxygen logger deployment locations

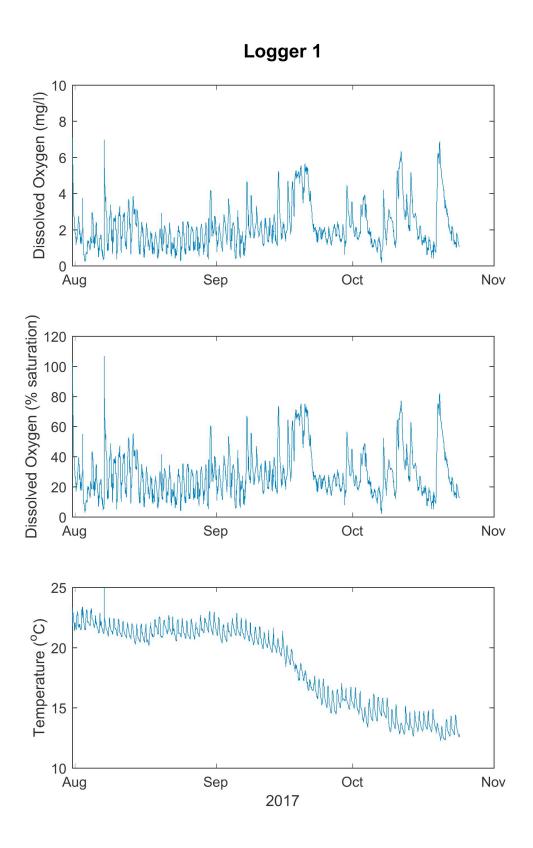
The dissolved oxygen loggers deployed under the bottom barriers recorded a rapid and prolonged depletion of oxygen while the lake water above the barriers remained saturated (figures 5-8). The conditions around loggers 2 and 3 (figure 6 and 7) quickly became anoxic (<1mg/L) and remained so throughout the treatment period. Logger 1, also deployed under a barrier, was checked after one week of deployment (7 August). It experienced significant oxygen depletion compared to the control but showed variability over time (.2 mg/L - 6.9 mg/L, 2.2 mg/L average) (figure 5). It was located directly off the boat launch facility and may have been subjected to disturbance by boat activity. This was also the area where two barriers were compromised for a short duration.

Figure 5: Dissolved oxygen logger #1 under bottom barrier

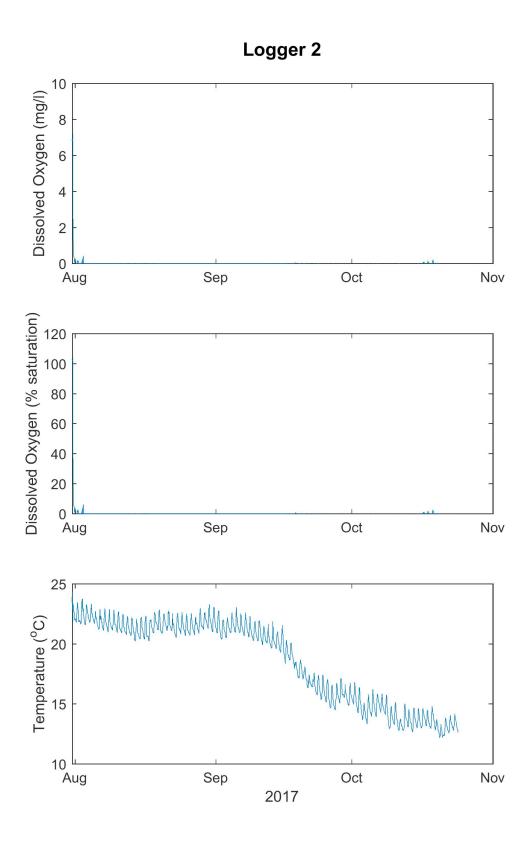
Figure 6: Dissolved oxygen logger #2 under bottom barrier

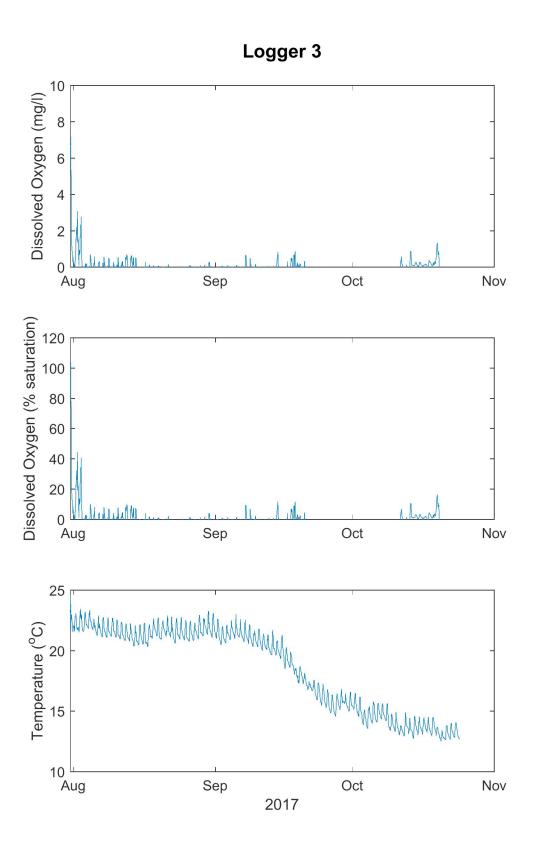
Figure 7: Dissolved oxygen logger #3 under bottom barrier

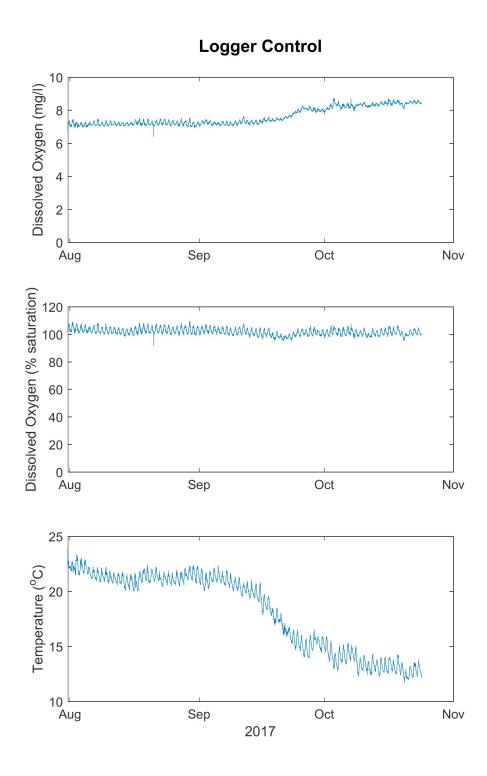
The dissolved oxygen logger attached to the TERC water quality station continued to record saturated oxygen conditions (6.4 - 8.8 mg/L, 7.6 mg/L average) throughout the treatment (figure 8).

Figure 8: Dissolved oxygen logger #4 attached to TERC nearshore station at 2m depth on top of bottom barrier adjacent to the Sand Harbor boat launch. This logger served as a control during the Phase 1 deployment.
