**Delineation of the Asian Clam (*Corbicula fluminea*) Population
at Sand Harbor State Park, Nevada**

**Report to the Nevada Division of State Lands and the Tahoe Regional
Planning Agency**

Brant Allen, Katie Senft, and Brandon Berry
UC Davis Tahoe Environmental Research Center

November 2017

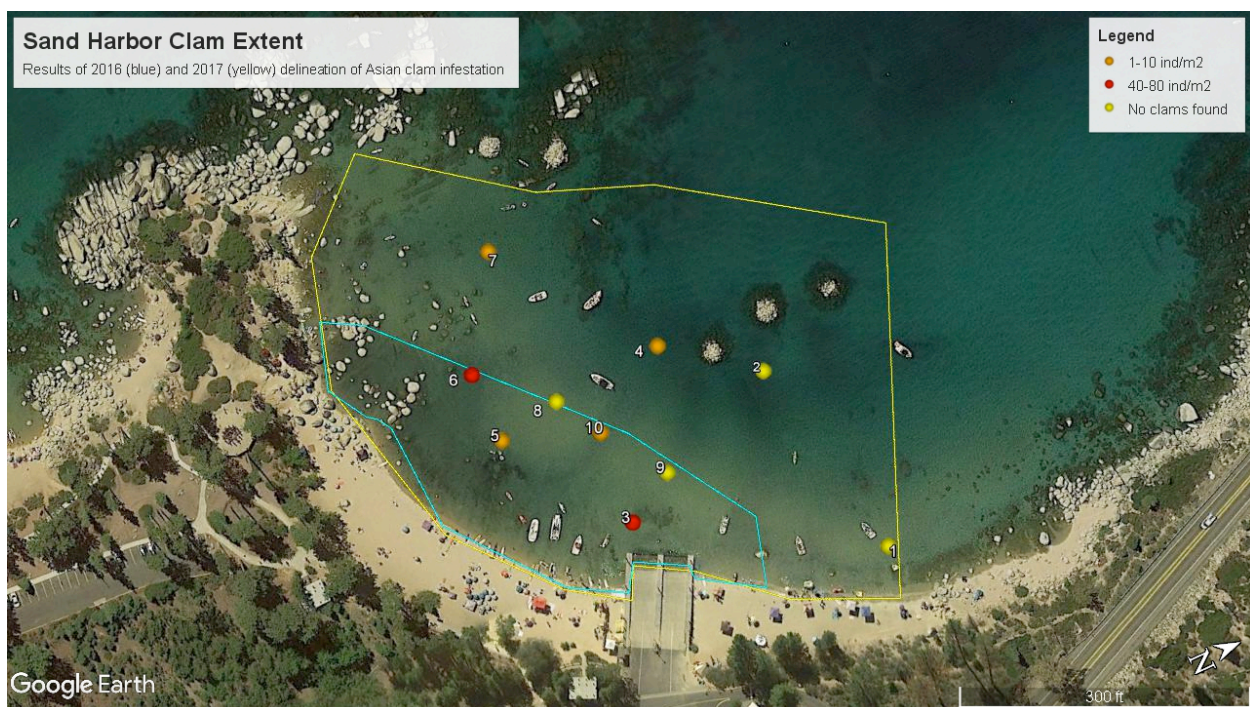
Figure 1: Change in areal coverage of the Asian clam population in the vicinity of the Sand Harbor State Park boat launch June 2016 to June 2017.

In June of 2016 TERC researchers conducted scuba surveys to delineate the area of clam infestation surrounding the Sand Harbor boat launch (Figure 1). No treatment was conducted during the summer of 2016 allowing unencumbered reproduction and expansion of the Asian clam population. In determining the new and potentially larger extent of the area in need of treatment, researchers used the previous boundary of clam infestation as a baseline making the assumption there was not a reduction in the populated area.

Low densities of clams were found beyond the north and west sides of the 2016 infestation expanding the area to be treated to 5.5 acres (Figure 1). No clams were found in the newly wetted shorezone less than a depth of 6 ft.

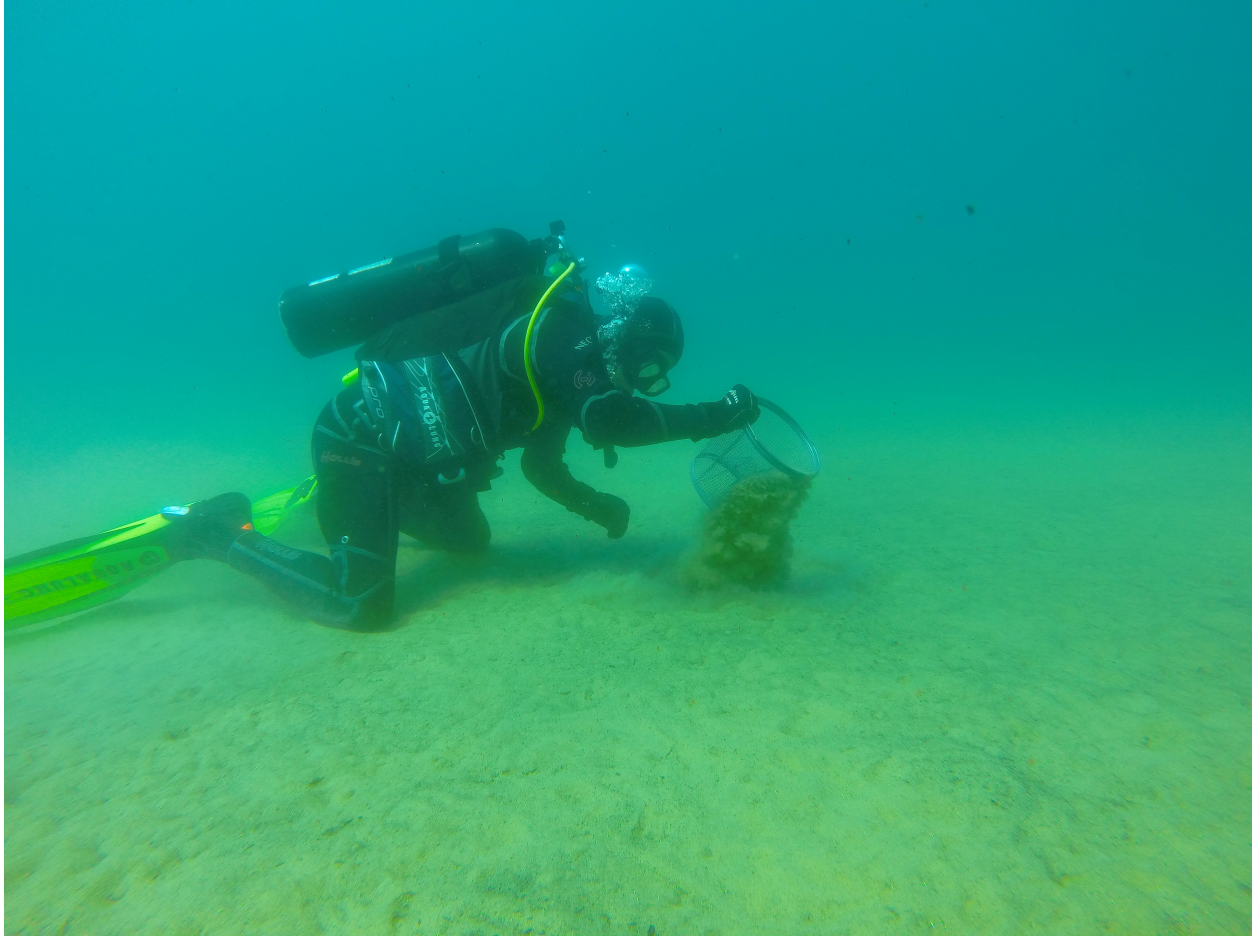
Figure 2: Scuba divers sieved substrate along transects to locate clams buried below the surface.

Divers used fine mesh sieves to scoop the substrate to depth of about 6 inches, filtering any clams greater than 5mm from the sand and silt (Figure 2). This method allows a large amount of substrate to be checked in detail while visually surveying the surface of the substrate for the presence of both live and dead clams. Due to the time consuming sieving process, this method works best when refining population areas where as hand flipping is most efficient when assessing large areas for presence absence.
