## Assessment of the Phase 1 of the Asian Clam Treatment at Sand Harbor State Park June - November 2017

# Report to the Nevada Division of State Lands and the Tahoe Regional Planning Agency

Brant Allen, Katie Senft, and Brandon Berry UC Davis Tahoe Environmental Research Center

January 2018

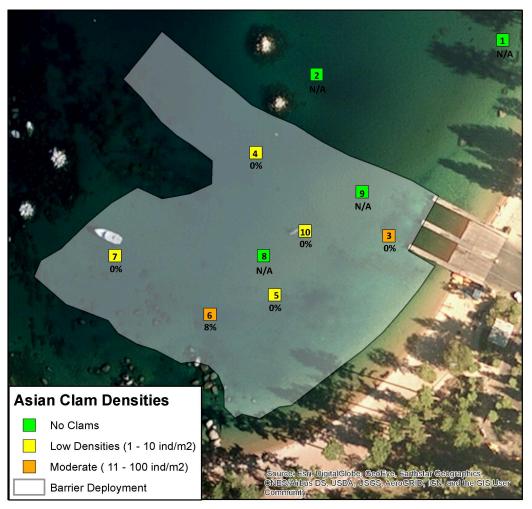
Live clam density was highly variable over the treatment area (0 - 79/m²) with clams only appearing in six of the ten plots. The variability could be due to differences in substrate conditions, a young population that hasn't yet filled in the available habitat, or both.

Figure 1: Location map of pre-treatment 1m<sup>2</sup> collections for density and percent mortality
